# The Merchants' Association

## SPECIAL REPORT

Merchants' Association Bureau  
of Inspection

SHOWING DIFFICULTIES ENCOUNTERED IN SECURING  
COMPLIANCE WITH SPECIFICATIONS IN  
WORK ON PUBLIC BUILDINGS.

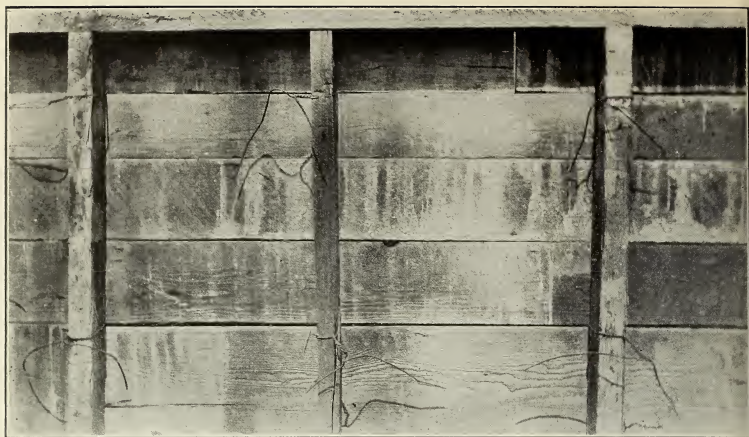
**Aug. 12th:** Work on forms started without any City Inspector on the job; quality of work and materials very poor; form lumber second-hand stuff. Reported to City Architect, who promised to put an inspector on by the 15th.

- Aug. 22nd:** Bureau Engineer on job with City Architect. Pointed out defects in forms, namely, poor, worn-out, second-hand lumber containing many holes and excessively loose joints. City Inspector Templeton promised that all holes would be tightly calked before concrete would be poured, which was only partly done.

Exhibit "A": Showing old lumber and large joints in forms. September, 1910.

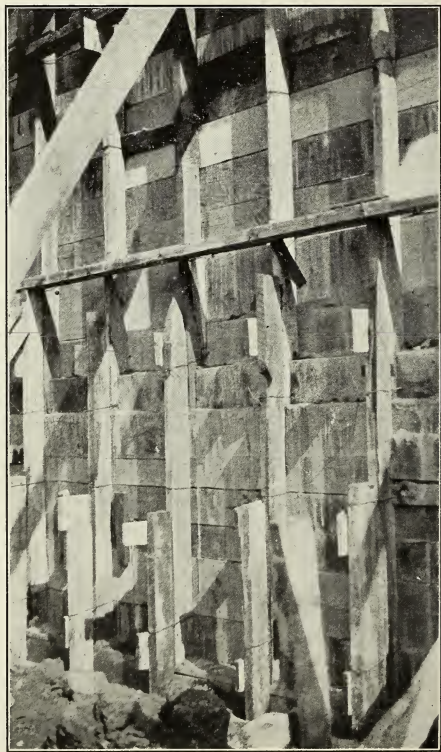
- Sept. 22nd:** Pouring footings and east stair-well; two city inspectors on job; forms at stair-well had not been properly calked, Templeton's promise to have same done notwithstanding, and much grout had leaked out.

Exhibit "B": Same as "A." Shows leakage and waste of cement through loose joints; concrete poured half way up. October, 1910.

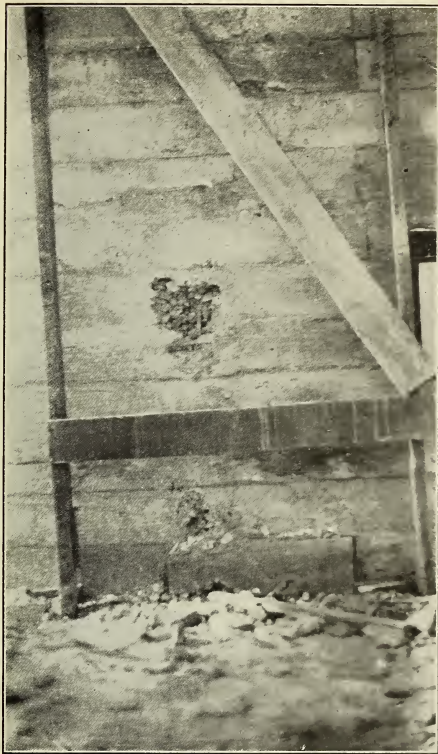
**Oct. 25th:** Cast-iron column set partly in concrete wall tilted  $\frac{3}{4}$  inch out of plumb. Should be cut free from concrete wall and reset. Outside of south stair-well stripped and showed a very large loose pocket of rock at north end. Contractor's men tried to board this up to keep it from being seen, but were not successful. So much poor work at this end of stair-well that entire end should be torn down and rebuilt. Work here is outrageously bad. Commissioner Newsom on job and this work was pointed out to him and complaint made of same.

Exhibit "C": Typical rock pocket in heating room wall. Cast iron column that is  $\frac{3}{4}$  inch out of plumb is just to right and on other side of wall. Note loose rock and voids at base of column, October 26, 1910.

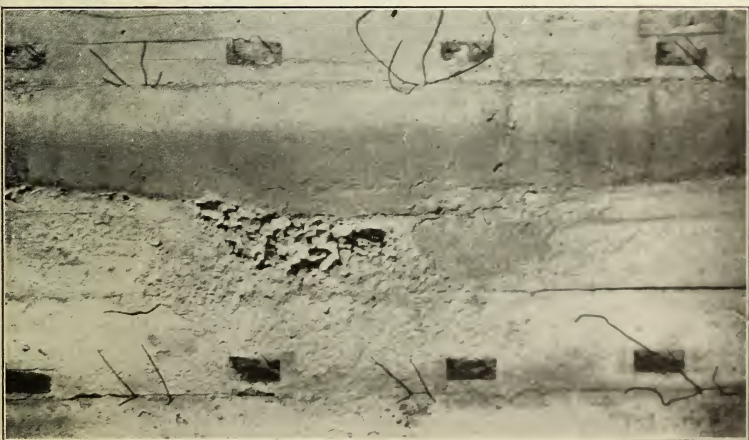
**Oct. 17th:** Stripping of forms on outside of east stair-well showed several bad voids due to careless work. A reinforced concrete column west side of stair-well full of voids at base and at point half way up; should be condemned and rebuilt. Had not been built in one operation. Front walls and furnace room walls stripped and some bad voids had been immediately patched with mortar. In one spot, steel was showing on exterior of wall.

Exhibit "D": Showing voids and result of improper workmanship on south side of east stair well, October 17, 1910.

(1) Column on west side of east stair-well should be rebuilt, as it contains many voids at base and about half way up.

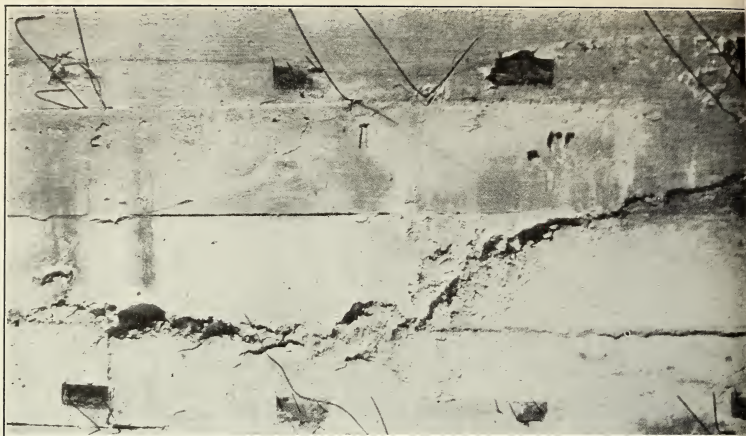
Exhibit "E": Showing voids and results of improper workmanship on south side of east stair-well.  
October 17, 1910.

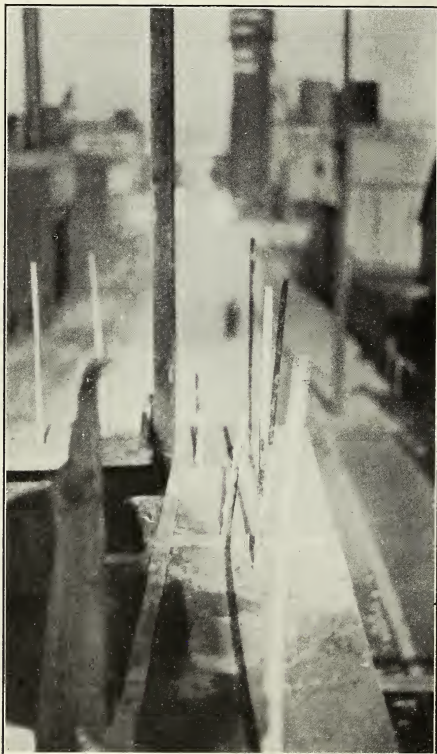
Exhibit "F": Showing steel reinforcing as placed in east stair-well. Vertical steel bars should be 1 inch from left-hand edge of wall, instead of about 4 inches as shown. October 26, 1910.

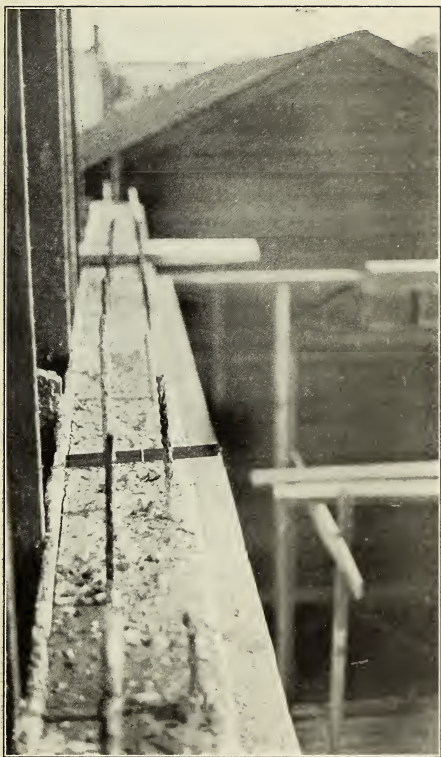
Exhibit "G": Showing steel reinforcing as placed in east stair-well. Steel should be 1 inch from each wall, instead of 2 inches to 3 inches. October 26, 1910.

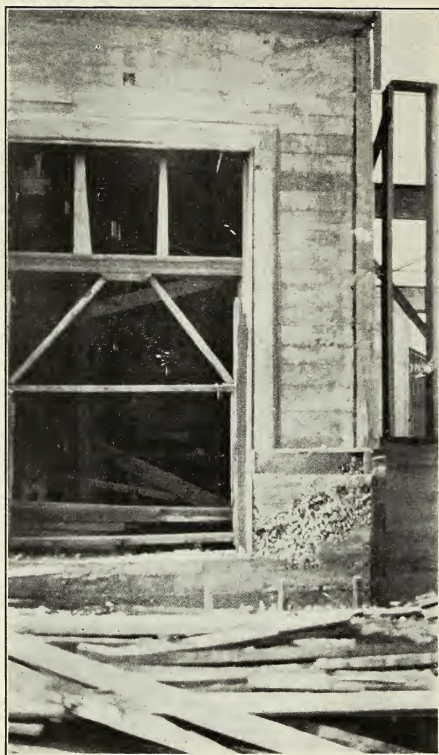
**Oct. 28th:** City Architect ordered forms of interior of south stair-well stripped so as to facilitate examination of loose rock pockets revealed by stripping outer forms. Stripping showed that loose rock pockets extended clear through wall and were more extensive than at first shown. Contractor had prepared mortar to patch up voids, but was ordered not to do so. However, pocket was patched over by mortar next day.

Exhibit "H": Showing loose rock pockets at north end of south stair-well. Voids are more extensive than here shown, because a thin skin of grout covers same. October 26, 1910.

(2) North end of south stair-well should be rebuilt. The loose rock pockets here are so extensive as to make patching impossible.

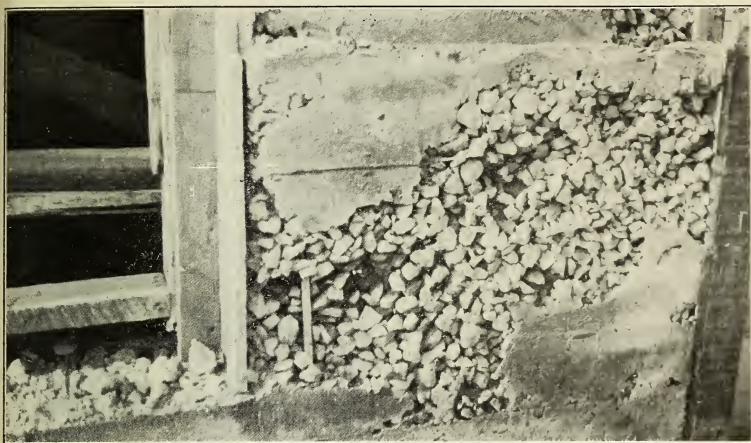
Exhibit "T": A closer view of "H" and showing how a thin skin of grout covers loose rock pockets. This rock is so loose that it can be taken out by hand.

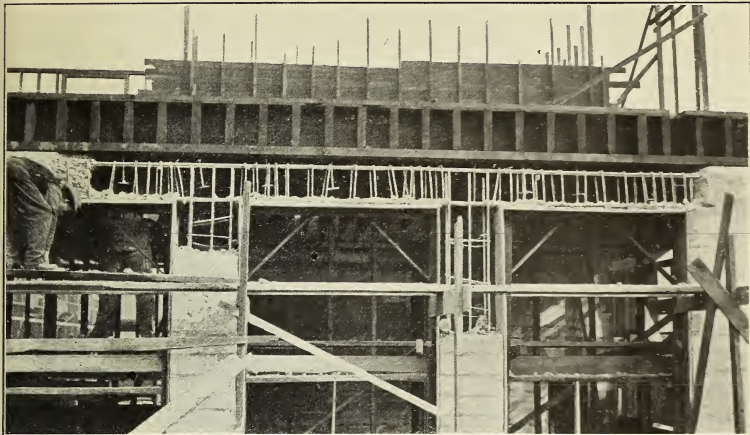
(3) Two columns between windows on Eighth-Street front are so full of voids as to preclude patching, and should be rebuilt. There are other similar columns that must be further examined before same can be said to be passible.

(4) In all the walls there are extensive rock pockets that have been plastered over and that must be opened up and dug out before the walls can be passed upon.

Exhibit "J": Showing a portion of the faulty work noted in paragraphs (3) and (4), and which had to be cut out.

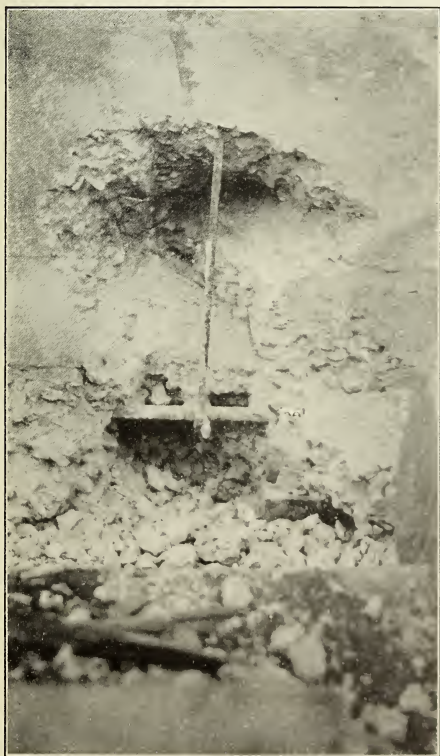
Exhibit "K": Showing how extensive was the faulty work noted in paragraphs (3) and (4).

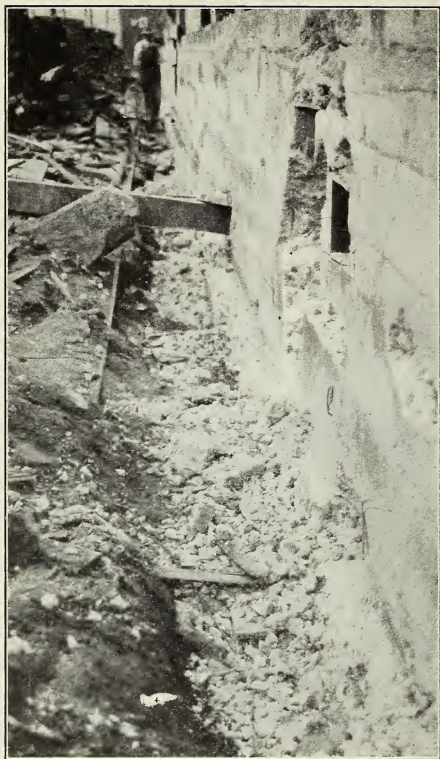
(5) In some places the bases of the footings show extensive loose rock pockets, and it will be necessary to dig the earth away from the same in order to make a proper examination.

Exhibit "L": Illustrates defects noted in paragraph (5).
